Debris/Ice/TPS Assessment and Integrated Photographic Analysis of Shuttle Mission STS-94

**DEBRIS/ICE/TPS ASSESSMENT
AND
INTEGRATED PHOTOGRAPHIC ANALYSIS
OF
SHUTTLE MISSION STS-94**

1 July 1997

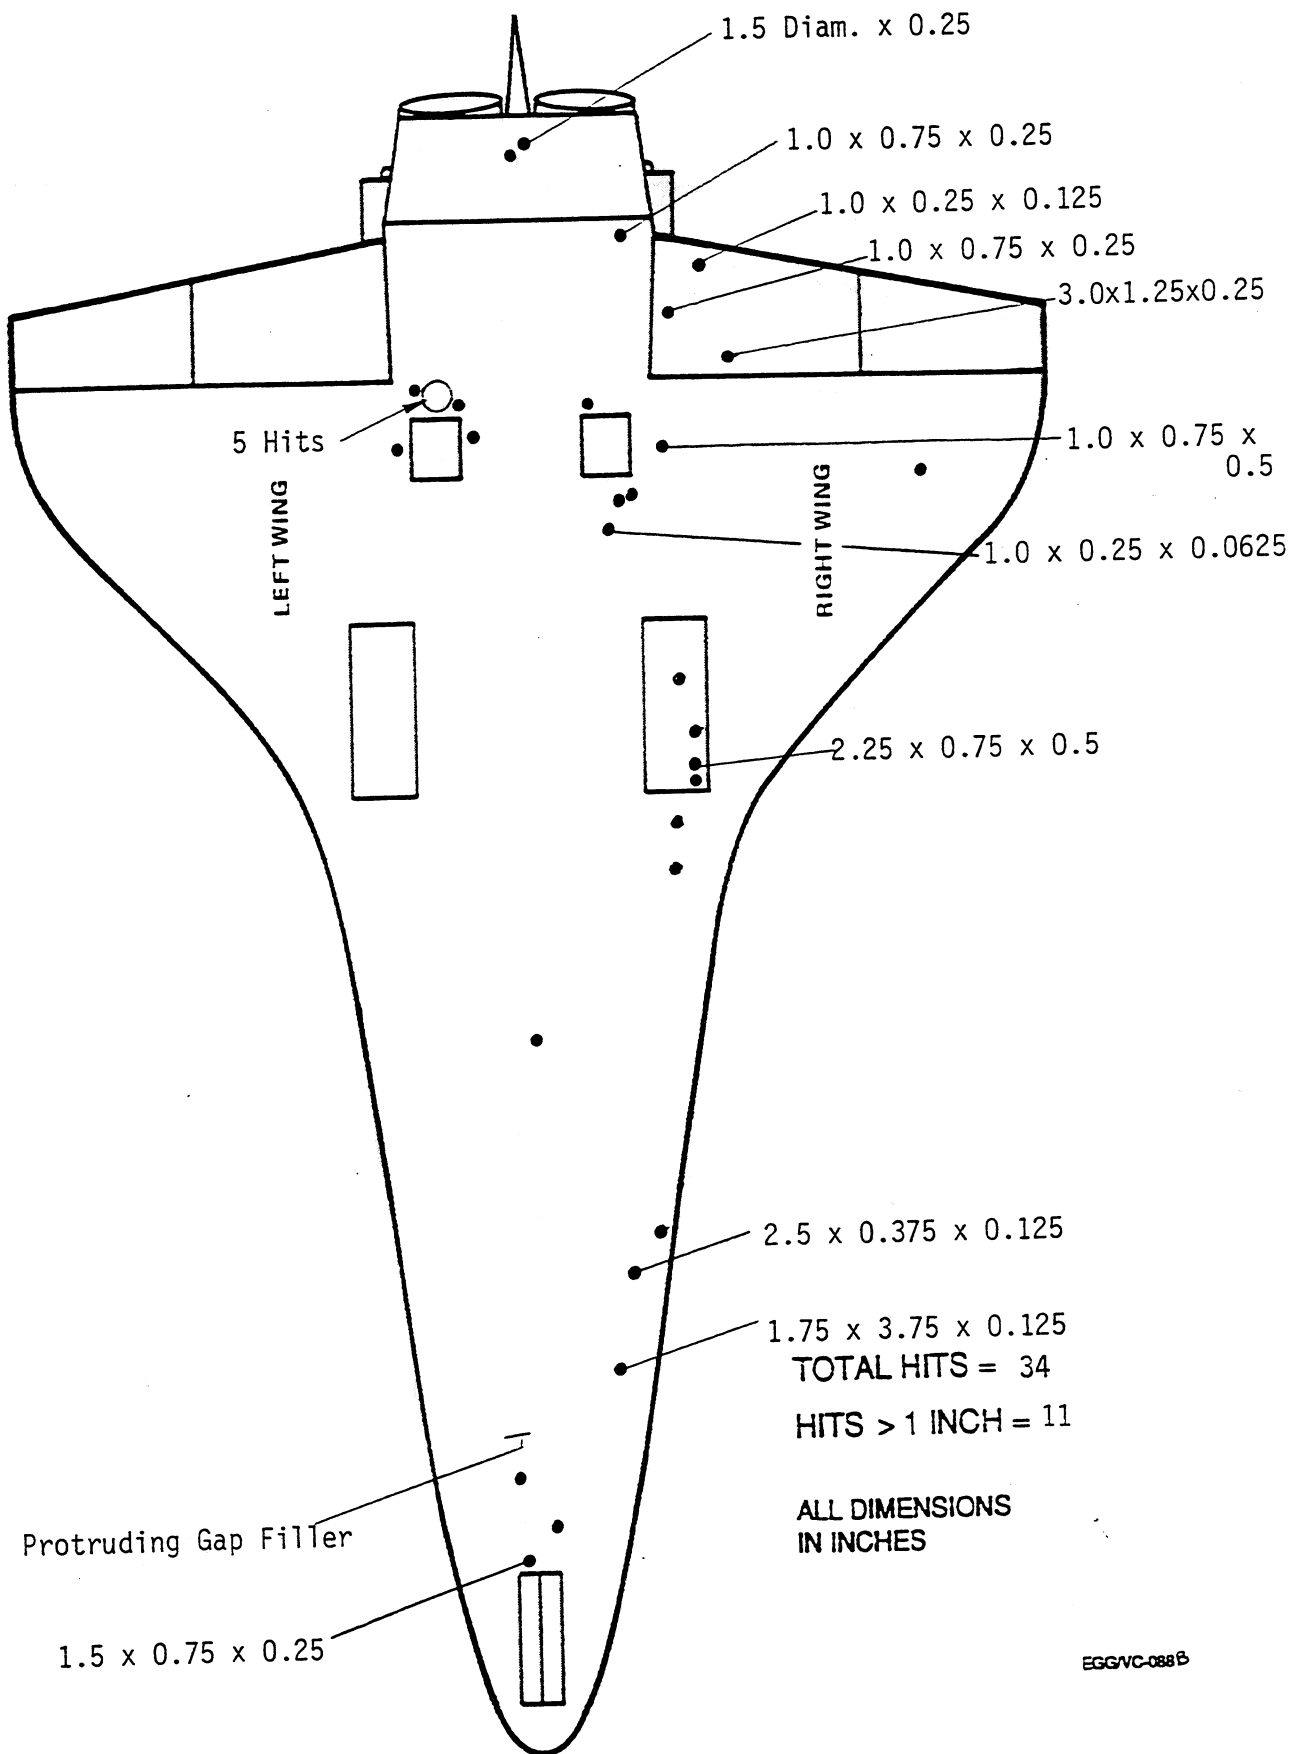
Figure 1: Orbiter Lower Surface Debris Damage Map

The Orbiter lower surface sustained a total of 34 hits, of which 11 had a major dimension of 1-inch or larger. The largest lower surface tile damage site was located on the right chine. The site measured 3.75 inches long by 1.75-inches wide by 0.125-inches deep.

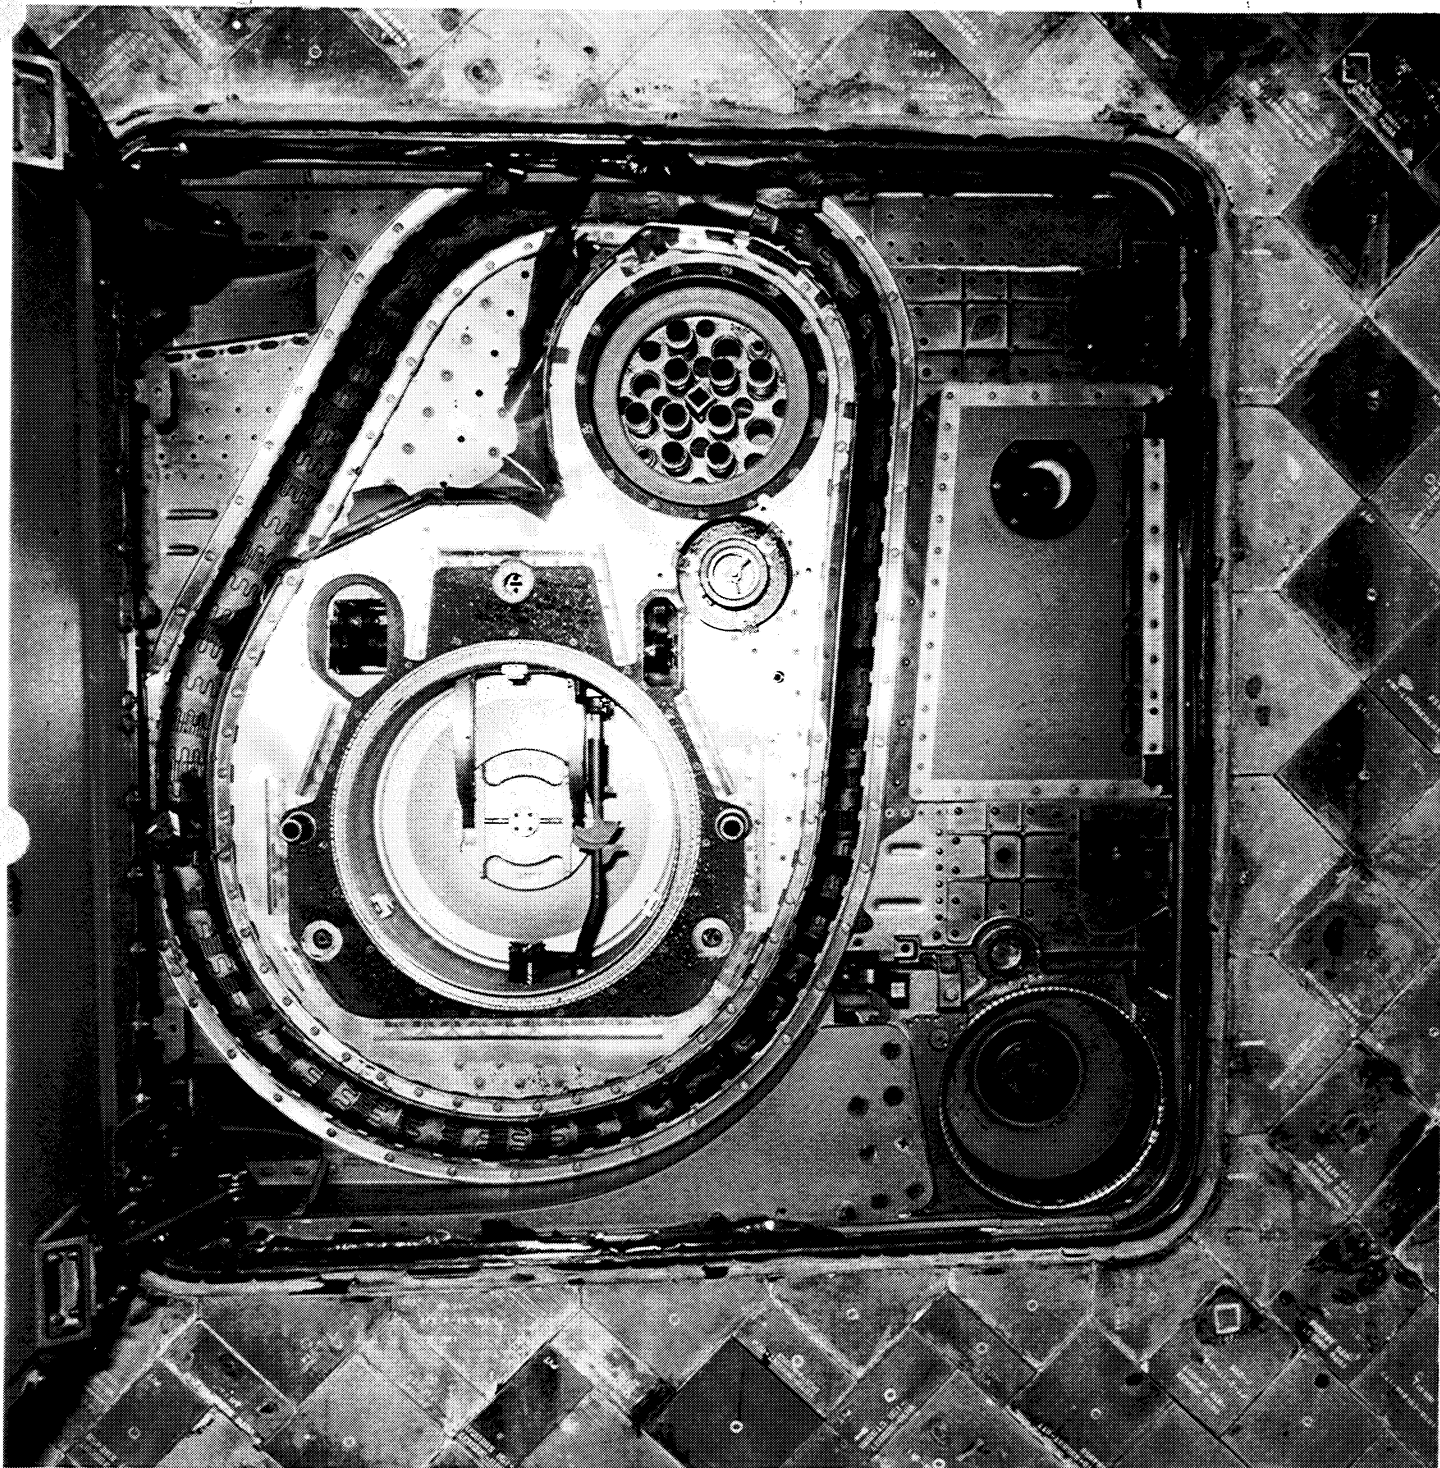
Photo 28: LO2 ET/ORB Umbilical

There were no TPS anomalies on the LO2 ET/ORB umbilical. Ice/frost accumulations were limited to small patches on the aft and inboard sides. Ice/frost fingers on the separation bolt pyrotechnic canister purge vents were typical.

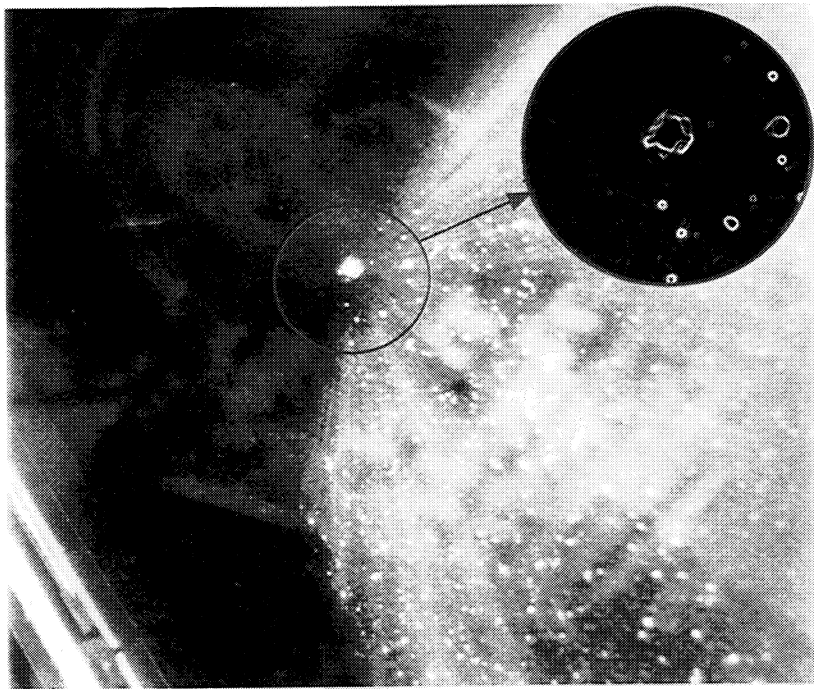
Figure 1.1.2 Debris Impact on Overhead Window #7

On mission day three, six Electronic Still Camera (ESC) pictures were down-linked by the STS-94 crew of a damage area on the outer pane of an Orbiter overhead window (Window #7). This damage probably resulted from a micro-meteoroid or orbital debris impact. Figure 1.1.2 is a view of the impact area from down-linked ESC picture number S94E5028. The impact area is enhanced and enlarged (inset) to show the extent of damage. No on-orbit analysis support was requested.

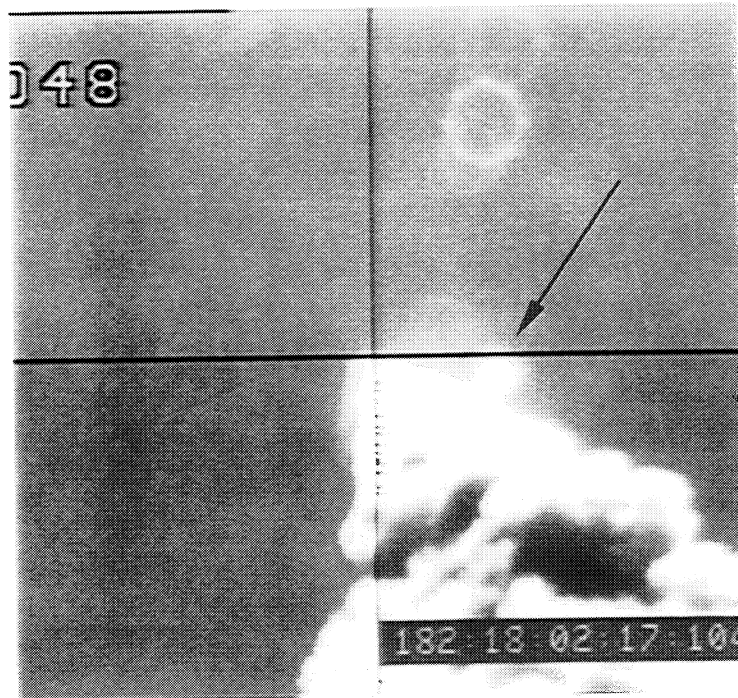
Figure 2.4 (A) Unusual Vapor-like Puff along Exhaust Plume

A white vapor-like puff (probably a cloud) appeared to extend laterally away from the SRB exhaust plume during ascent (18:02:17.1 UTC) (Camera OTV048).

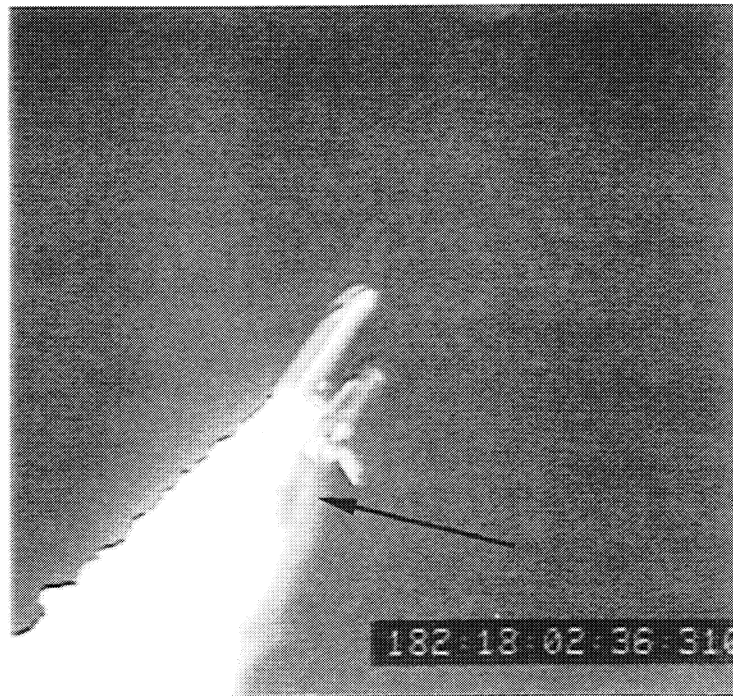
Figure 2.4 (B) Orange-colored Flare in SSME Exhaust Plume

Approximately five orange-colored flares (probably debris induced) were seen in the SSME exhaust plume during ascent between 18:02:27.984 and 18:02:36.31 UTC (Cameras E222, E224, KTV4A, KTV21A, ET213).

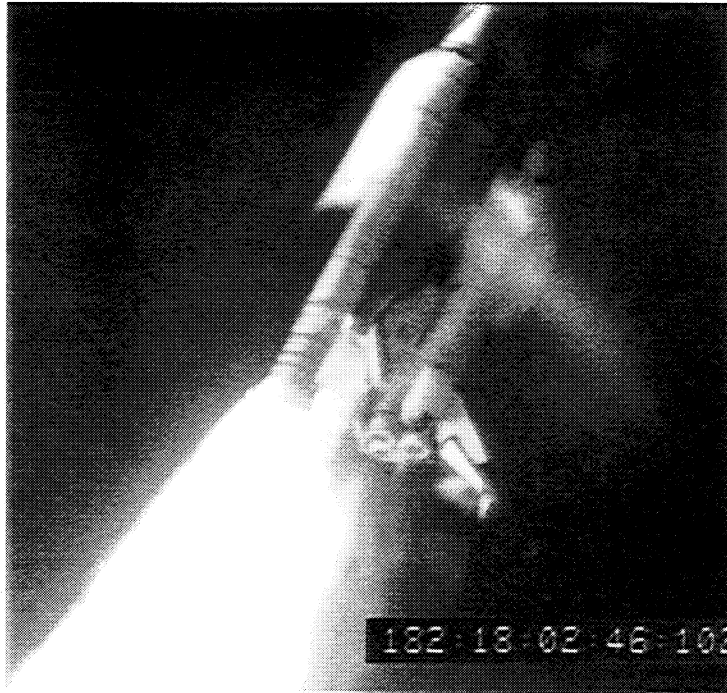
Figure 2.4 (C) Condensation Around the Launch Vehicle

Atmospheric condensation appeared to form a collar around the launch vehicle between 18:02:35.2 and 18:02:50 UTC (Cameras E207, E212, E222, E223, E224, ET207, ET208, ET212, KTV2, KTV13).

An orange-colored flash was seen near the Orbiter right wing tip at 18:02:45.802 UTC. The flash was not seen on the other long range tracking views screened. This flash occurred at the same time condensation was visible around the launch vehicle and was probably a reflection of the SRB exhaust plume on an area of visible moisture.

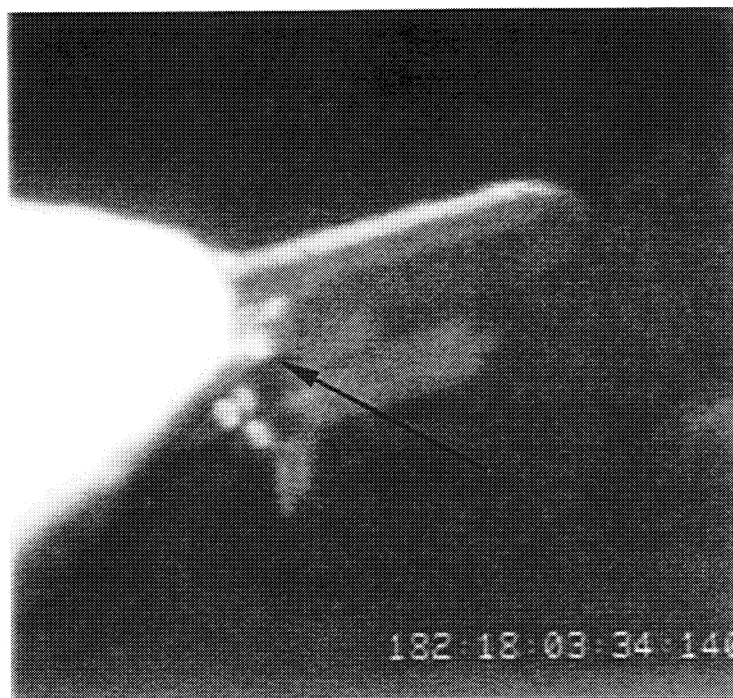
Figure 2.4 (D) Recirculation

Recirculation, or the expansion of burning gasses at the aft end of the vehicle, was seen during ascent (18:02:32.4 through 18:03:44.9 UTC) (Cameras E212, KTV13, ET208, ET212, KTV21A).

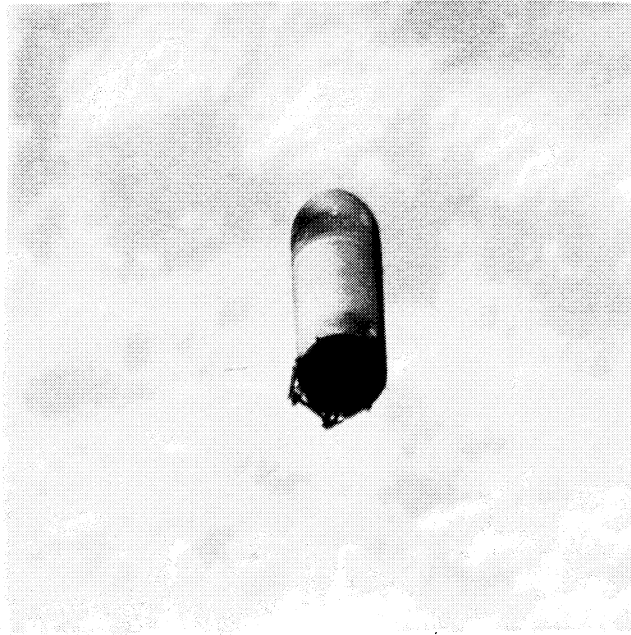
Figure 2.5.2 (A) Handheld Photograph of ET

The normal SRB separation motor burn scars were visible on the ET TPS.

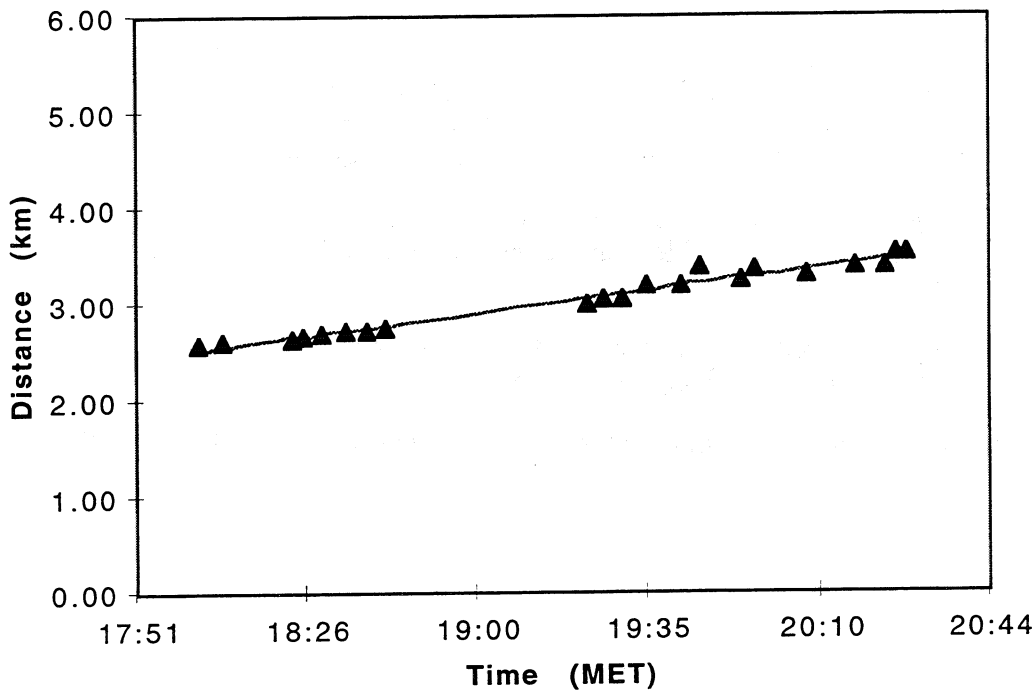
Figure 2.5.2 (B) ET Separation Velocity

The distance of the external tank was calculated on twenty frames. On the first usable view, the external tank was calculated to be at a distance of 2.6 kilometers away from the Orbiter at 18:04 MET. On the last view, 2 minutes and 23 seconds after the first view, the tank was calculated to be at a distance of 3.5 kilometers (18:06:23 MET). The tank separation average velocity was determined to be 6.6 meters/second (m/s), with an uncertainty of approximately 1 m/s. The tank tumble rate was approximately 1.8 degrees/second. The tank roll rate was 0.3 degrees/second.

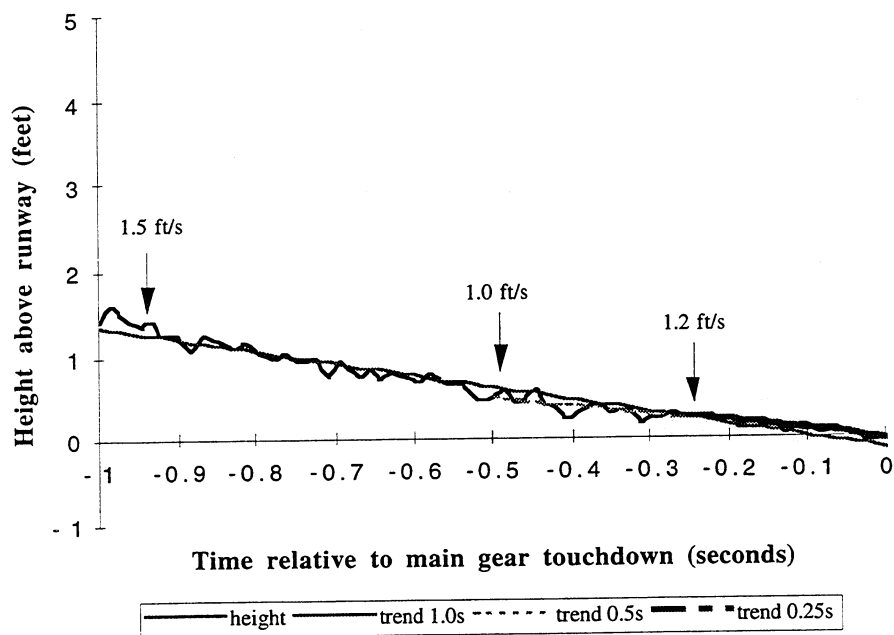
Figure 2.6.1 (A) Main Gear Height versus Time Prior to Touchdown

The measured main gear sink rate values were found to be below the maximum allowable values of 9.6 ft/sec for a 211,000 lb. vehicle and 6.0 ft/sec for a 240,000 lb. vehicle. The landing weight of the STS-94 Orbiter was reported to be 230,911 lb. The sink rate measurements for STS-94 are given in Table 2.6.1. In Figure 2.6.1(A), and 2.6.1(B), the trends of the measured data points for the image data are illustrated.
